Renata PAMIĆ, Franc POHLEVEN

PROTECTION THROUGH CONSTRUCTION OF A WOODEN MONUMENT IN RADOMLJE (SLOVENIA)

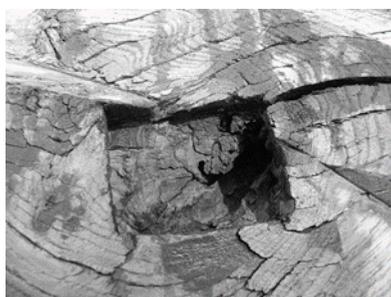
Once the monument was taken down, it was examined in detail and the damage to it documented. The monument was protected by a copper cover, which had caused galvanic corrosion where the metal came in contact with the wood. Flaking, dislodged wooden inserts and rotten wood were documented over the entire surface coating. The multi-layered decorative coatings were cracked and photo-degraded (fig. 1). Cracks, wooden inserts and rotten parts were visible where water had flowed into the wood. The greatest damage was found in the lower part of the monument, in the area of screwing, where radial cracks extended to the bore (fig. 2).

Fig. 1. Detail of photo-degraded surface and rotten area

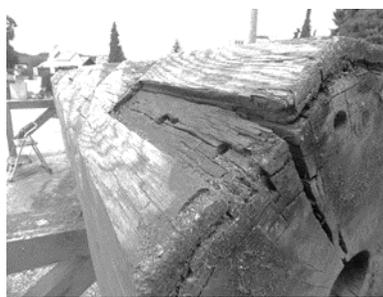
Fig. 2. Damage to monument due to the fastening system

A 10 cm bore in the wood was only 50 cm deep and was badly cracked. The monument was mounted on a metal tube with 9 cm diameter and a height of 50 cm, which was fixed in a granite pedestal and filled with cement mass. The slats were enclosed within a metal ring which did not allow water to run off, therefore it accumulated, saturated the bottom of the monument and caused intense rotting.

At the points where the ring was screwed in place, pronounced tearing of the wood fibres and, to a height of 200 cm, radial and longitudinal cracks of up to 10 cm deep in the direction of the wood fibres were found. Brown rot and white rot, slightly higher above the screws, were found. On account of this, the lower section of the monument was severely damaged.

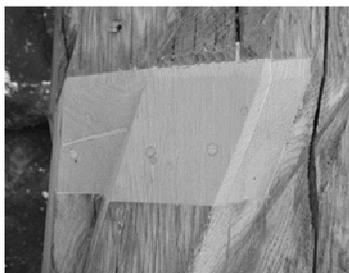
Fig. 3. Insert of new oak wood

The filling places (deepening, niches) and wooden inserts were cut in the direction of the water outflow and reinforced with dowels and urethane glue (fig. 3). The rotten parts were filled with epoxy binder with added wood flour and AR glass fibres. The rotten parts not suitable for the insertion of wooden implants were thoroughly cleaned and strengthened with dowels and Paraloid B-72. In the open parts of the damage, unbound dry wood flour was scattered and the remaining volume was filled with Araldite. When the epoxy mass hardened, the residue of unbound wood flour was blown out through a water drainage duct, drilled at the lowest point of damage. The opening was covered with stainless steel wire wool, allowing drainage and aeration but, at the same time, preventing access for insects (fig. 4).

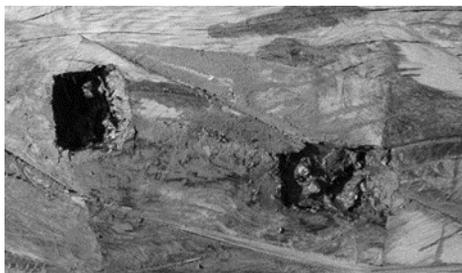
Fig. 4. Reinforcement of rotten parts with dowels and epoxy mass

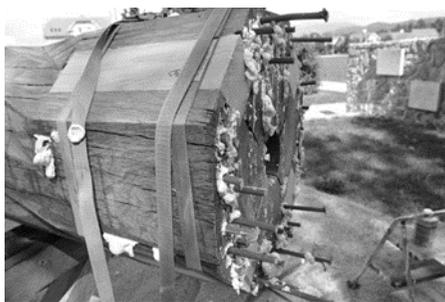
Fig. 5. Reinforcement of lower part of monument with oak dowels and prisms inserted with urethane adhesive

The rotten wood at the site of the previous bolting was removed with a joiner's chisel, the areas were impregnated with Silvanolin and substitutive glued oak prisms measuring $35 \times 10 \times 10$ cm were inserted. The peripheral part of the monument was structurally remediated so that, with the new concept of installation, it could bear the static load. The wood was drilled around the perimeter at a width of 10 cm and to a depth of 40 cm. It was then impregnated with Silvanolin and oak dowels were inserted using urethane adhesive (fig. 5).

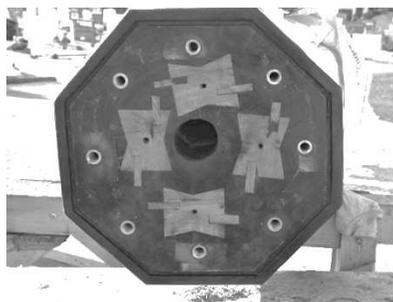
Fig. 6. Arrangement to stainless steel inserts with an internal thread. Drainage of main cracks through wedges

The weakened zone of major radial cracks was fastened together with four butterfly wedges of glued oak wood and additionally secured against extraction. The cracks were cleaned beforehand, cleared by blowing and then impregnated with Silvanolin. In order to prevent the accumulation and retention of water above the wedges, drainage of the main cracks was provided through the wedges. The wedges were glued with urethane glue only at the sides and, on the edge above, the upper surface of the wedges was hollowed out into a funnel-like shape towards the centre, where a hole of 0.8 cm in diameter was drilled and covered with a mesh against insects. At a distance of 1.5 cm from the perimeter, a drip chamfer was also carved on the lower surface of the monument (fig. 6).

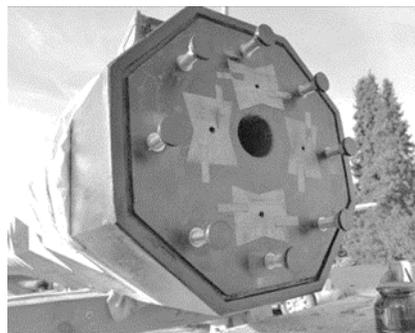
Fig. 8. Adjustable supporting elements of the monument

Since the new tube, with a height of 195 cm (135 cm above the pedestal and 60 cm in the pedestal) was sufficient to bear 60% of the load, eight M20 bolts were inserted on the periphery of the monument, to bear the remaining 40% of the load. They were bolted into stainless steel inserts with an internal thread. Each insert had a diameter of 3 cm and height of 10.5 cm, with a thread depth of 10 cm. The inserts with bolts were installed in a radius of 20 cm, 4 in replacement oak prisms in the original mounting points, and 4 in special oak bushings with a diameter of 5 cm and a height of 15 cm (fig. 8).

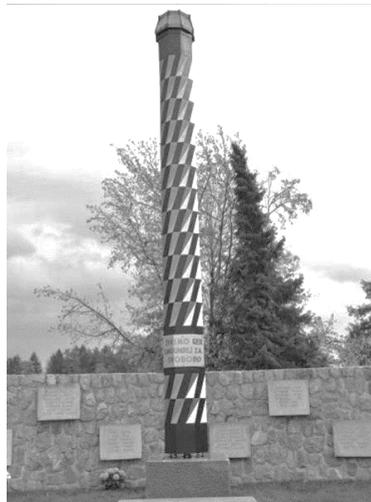
Fig. 9. Monument after restoration

The innovative and statically-verified load-bearing system applied helps shape the architectural appearance of the monument and, at the same time, enables protection through construction (fig. 9).
