Csilla VANYA

## DAMAGE PROBLEMS IN GLUED LAMINATED TIMBER

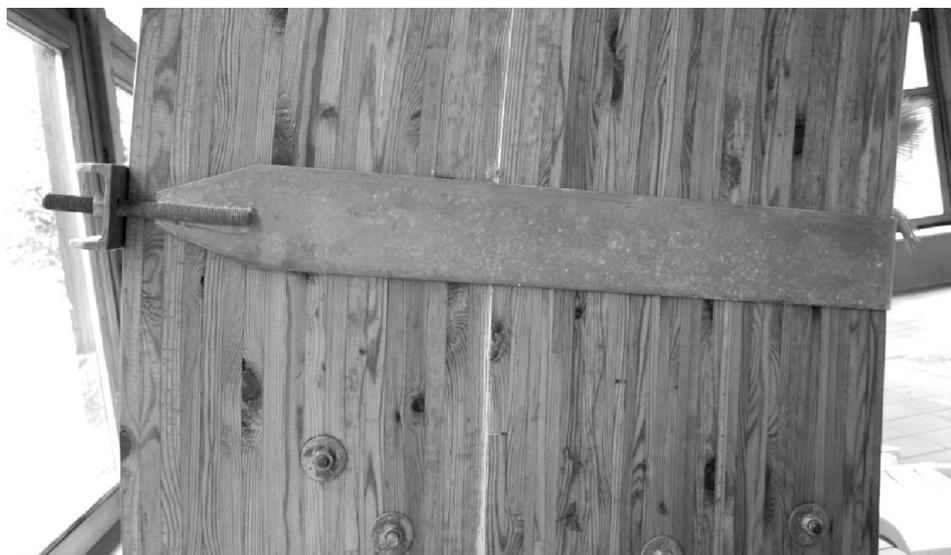
**Fig. 1. Steel bandage element on the frame column in the pool at Hajdúszoboszló**  
*Rys. 1. Stalowa opaska na kolumnie szkieletu konstrukcji – basen w Hajdúszoboszló*

Typical problems were cracks on the ends of the beams, and delamination at the metal connectors. The bolted connections were hindering the shrinking and bulking, and the beam showed splits between the bolts. The effect of the hindered deformation was also examined at the University of West Hungary Testlab.

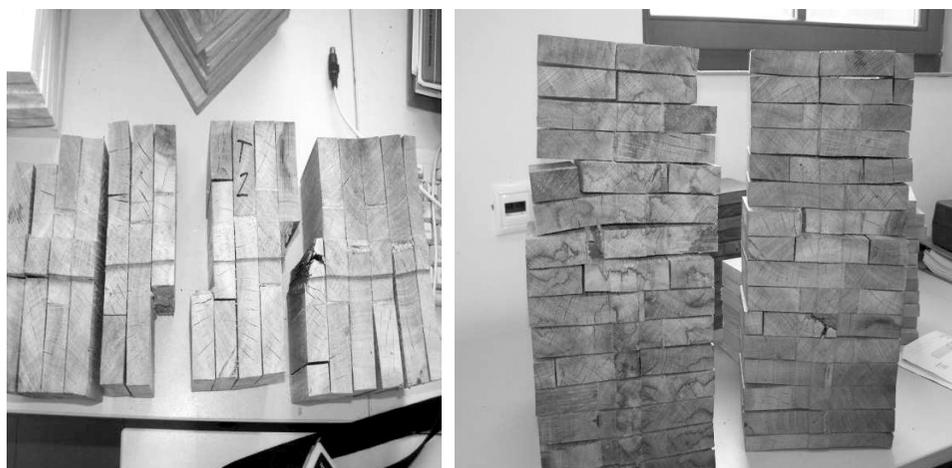
In addition, railway sleepers made of oak were examined. The test specimens were made by Lignum Európa Ltd. with the Swedish Cascomin 1247 adhesive. Delamination was more extensive than our proposed limit. Therefore, we can conclude that glulam blocks are not applicable for railway sleepers, even if they are made of oak.

**Fig. 2. Delamination on oak test specimens**  
*Rys. 2. Rozwarstwienie na próbkach dębu*
