## **THE STATE OF PRESERVATION OF ARCHAEOLOGICAL WOOD UNCOVERED IN THE GROTTA FOUNDATIONS OF THE RETAINING WALL OF THE PALACE MUSEUM IN WILANÓW**

*The following paper presents the results of the examination of archaeological wood from excavations carried out in the gardens of Wilanów Palace. The main purpose of the research work was to determine its state of preservation. In order to accomplish this, chemical and physical examinations were carried out on wood samples taken from the level of the grotto foundations.*

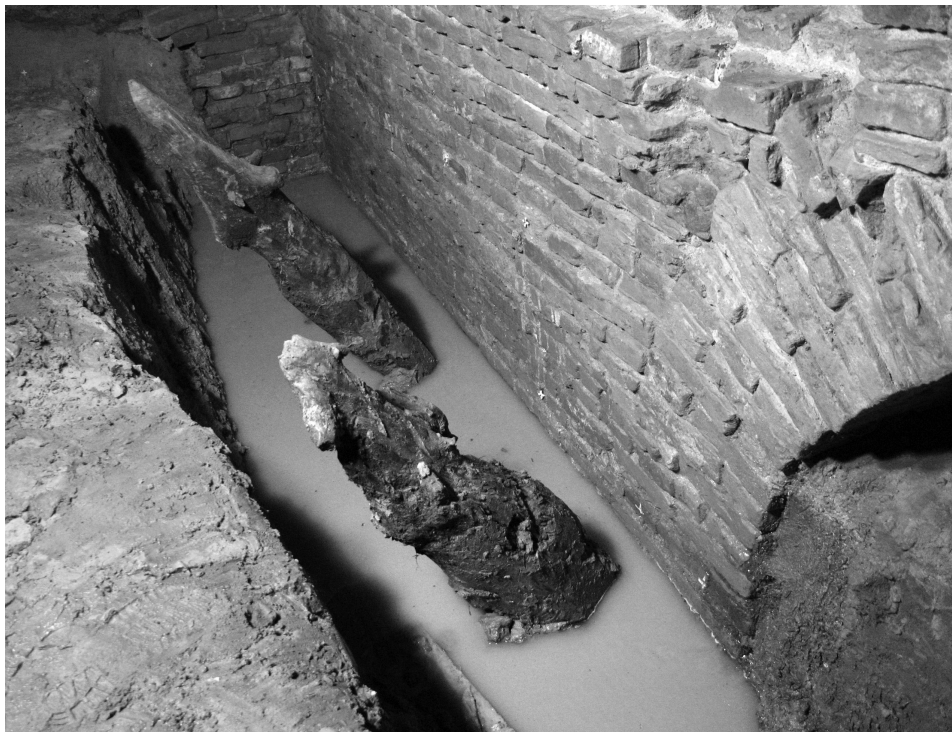
The function of the construction [622] is not clear. It consists of long piles of 120 cm in length, set at a 45° angle relative to the face of the wall, embedded beneath the footing of the foundations.

**Fig. 1. Work at the grotto foundations – South-East; a fragment of construction [622] is visible, trial pit 60. [photo Michał Aniszewski]**  
*Rys. 1. Prace przy fundamentach Groty – SE, widoczny fragment konstrukcji [622], sondaż 60. [fot. Michał Aniszewski]*

Undoubtedly, this construction appeared before the creation of the wall itself. It may have originally functioned as a formwork designed to protect the ditch from earth slides during the bricklaying. Driving a row of piles into the natural layers found beneath the construction level may have also served to demarcate the construction line, defining the position of the foundations and the eastern wall of the grotto.
