Simić I, Džinčić I, Palija T. 2023. The influence of moisture content on strength of window corner joint. *Drewno. Prace naukowe. Doniesienia. Komunikaty* 66 (212): 00018. <https://doi.org/10.53502/wood-176609>

### The Influence of Moisture Content on Strength of Window Corner Joint

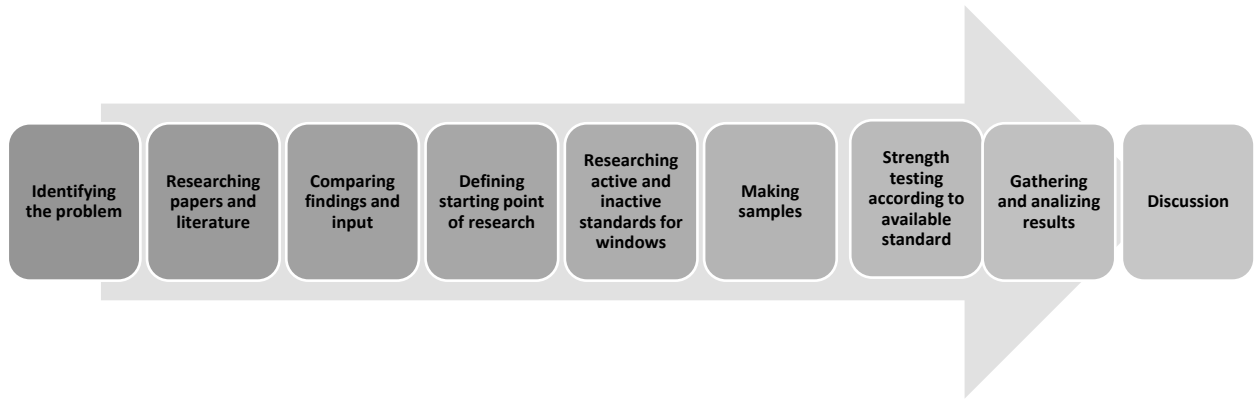
Fig. 1. Flow chart of research methodology

Since windows have a specific place in the building (they are located in a place that has the strictest operating conditions – on the inside there is a relatively constant climate, while on the outside the climate is quite variable with oscillations in weather conditions), the corner joint is influenced by multiple factors. With changes in these factors, the quality of the joint also changes, thus it is very important to know and understand their influence. The factors that affect the quality, i.e. the load-bearing capacity of the window corner joint, are the type of joint, gluing surface, machining accuracy, closeness of fit, type of wood, wood moisture and gluing regimes. In Figure 1 a flowchart of the research methodology is given.

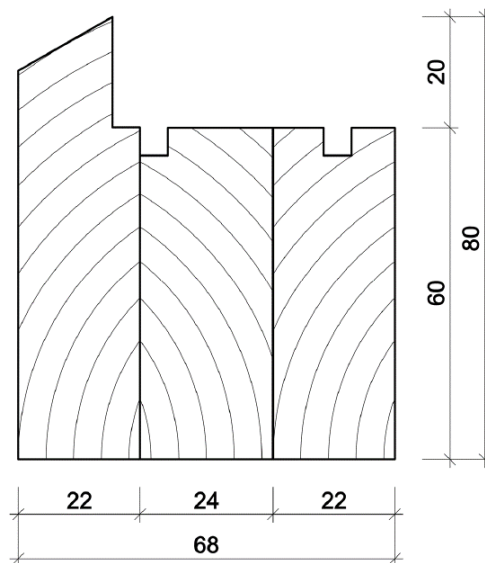
Fig. 1. Transverse appearance and dimensions of window frame beam (given dimensions are in mm)

Similar information that could act as the starting point for further work could not be found in any of the papers listed. The samples were made in a company that produces wooden doors and windows. The cross section of the beams used for making the samples was 68 x 80 mm (Figure 2), while the beams themselves were made of three lamellas. The dimensions of the outer lamellae are 22 x 80 mm and the middle 24 x 80 mm. A window with the specified cross section (IV68) is the most common window profile produced in local companies. All the samples had the same type of joint, a double mortise and tenon with a constant gluing surface of around 0.225 m<sup>2</sup>.

the appropriate excess. After production of the lamellas, their moisture was checked. After checking the moisture, the lamellas were glued according to the pattern shown in Figure 2. The glue was applied by hand.

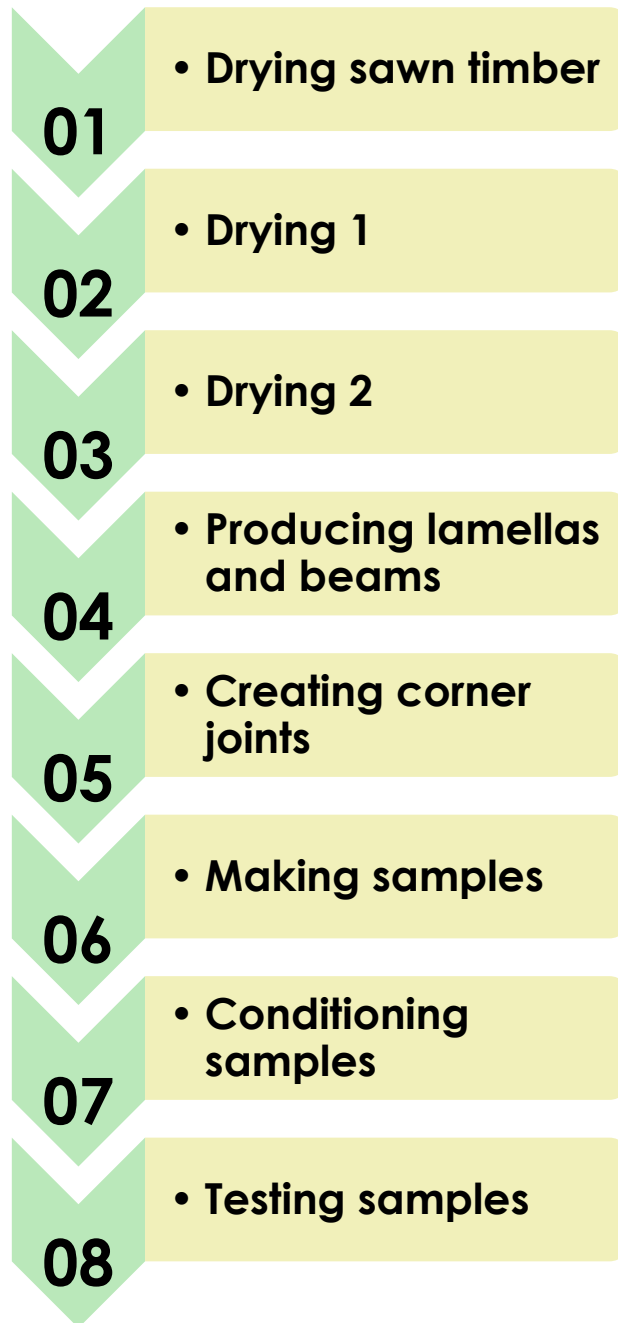
Fig. 2. Flow chart of research process

PVAc class D3 glue was used to join the lamellas and corner joints of the window samples. During the production process, the machining accuracy and the closeness of fit were controlled. Figure 3 shows the flow chart of the research process.

After the period of natural drying, the material was sorted by thickness (for the middle and outer lamellas) and sent for dehumidification kiln drying. The first group of sawn timber came out of the kiln after reaching an equilibrium moisture content of  $18 \pm 2\%$ . The rest of the sawn timber left the dehumidification kiln after the moisture content reached  $12 \pm 2\%$ . The dried sawn timber was then cut into elements with

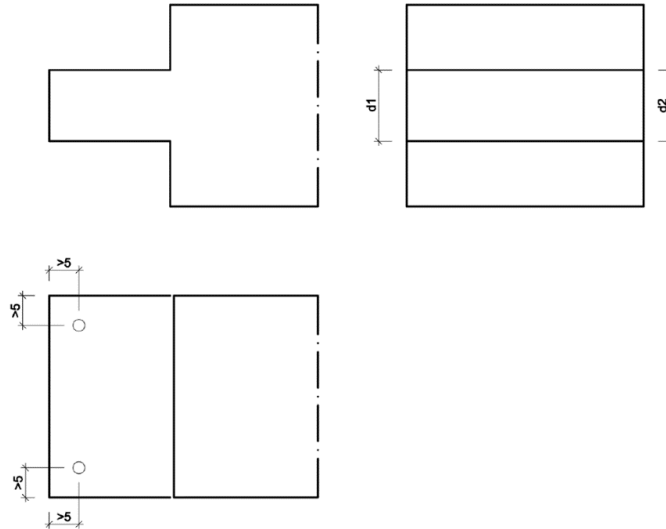
Fig. 3. Measuring points

The profiles and joints were made at SCM's machining center. Before joining, the thicknesses of the mortise and tenon were measured to determine the machining

accuracy and the closeness of fit. The measurement was performed with a caliper with an accuracy of 0.01 mm, at two measuring points, as shown in Figure 4.

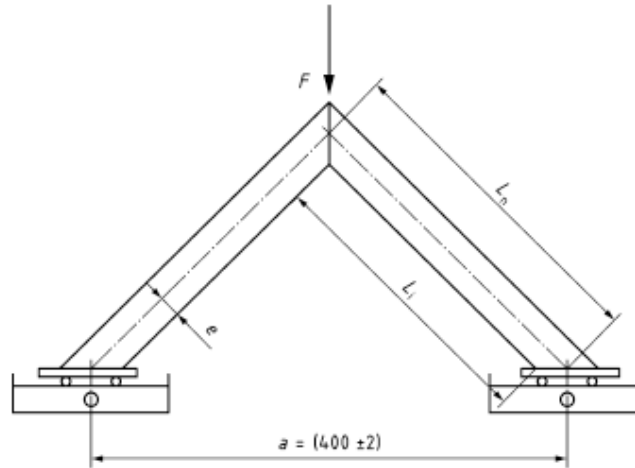
Fig. 5. Direction of force during test according to standard EN 514:2018

Due to the lack of a standard intended for testing the strength of corner joints of wooden windows, the test was performed according to the standard for testing PVC joints – EN 514, Figure 5. A similar testing method was used by other authors [Podlena et al. 2017; Podlena, Borůvka, and Bomba 2015]. In this

According to standard EN 514:2018, the samples were made as window corners so that one segment should have a length of  $385 \pm 2$  mm, and the diagonal distance from the ends of both segments is  $400 \pm 2$  mm. The sample was positioned on 2 trolleys in order to eliminate side forces, as shown in Figure 5. Force was applied as axial load on the edge of the sample with the speed of application of 50 mm/min. Force was applied until the sample failed.

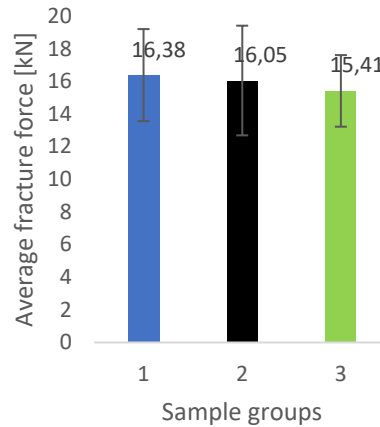
**Fig. 6.** Average value of fracture force for sample groups

have higher strength. When comparing the average tested strength of the samples, the Group 1 samples had the highest value of 16.38 kN. Group 2 had an average strength of 16.04 kN, while that of Group 3 was 15.41 kN (Figure 6).

Observing the average fracture values for all the three groups of samples, there is a difference in the strength of the angular joints. Namely, the Group 1 samples made from beams that were dried to the recommended moisture content of  $12 \pm 2\%$  were expected to have the highest strength. Among the other

groups, Group 2 (horizontal beam samples with a moisture content of  $12 \pm 2\%$  and vertical beams with a moisture content of  $18 \pm 2\%$ ) obtained a higher average value of joint strength than Group 3 (vertical beam samples with a moisture content of  $18 \pm 2\%$  and horizontal beams with a moisture content of  $12 \pm 2\%$ ). This distribution of results was expected before the study, however, the difference between the obtained results of the groups is smaller than expected. The deviation of this difference from the expected value was because it was originally planned to test the samples at the moisture content of the beams that they had at the time of making the window frames ( $12 \pm 2\%$  and  $18 \pm 2\%$ ). Nevertheless, during the research it was concluded that this does not reflect the real conditions in which the mentioned product (window) will be used. From the moment of the production of the window frame until the moment of its installation in the building, a certain time will pass, which is long enough for the moisture of all the beams within one frame to equalize and reach the moisture of operating conditions ( $12 \pm 2\%$ ). Therefore, before testing the samples they were conditioned to the mentioned moisture content ( $12 \pm 2\%$ ). Furthermore, the used PVA-c adhesives are designed in such a way (with increased elasticity) to be able to cover a wide range of wood moisture (6-20%) with a small loss of the prescribed properties.

In relation to the control group (Group 1 samples), the other two groups do not have excessive deviations (Group 2  $\approx 5.43\%$  difference, Group 3  $\approx 8.9\%$ ). Nonetheless, if this difference is observed from the
